# Mitigating Corrosion in Mg Sheet in Conjunction with a Sheet-Joining Method that Satisfies Structural Requirements within Subassemblies

Project ID # mat143

June 11, 2019

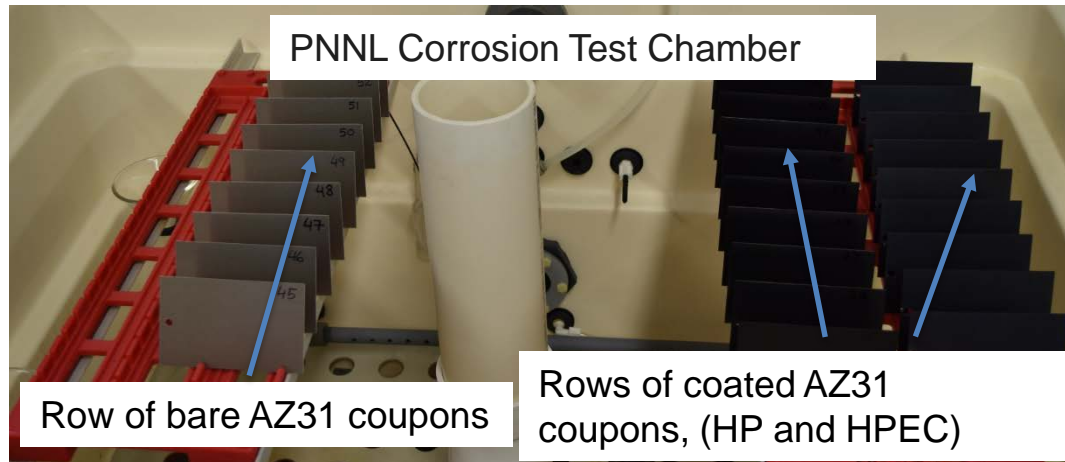
- ASTM B117 test for 1500 hours (~2 months)
- Corrosion coupons (3" x 5") placed at an inclination on the testing trays

Test chamber temperature : 35° C  
5% sodium chloride solution  
pH of the solution: 6.5 – 7.2  
Fog collection rate: 1 – 2 ml/ hr  
Test duration : Up to 1500 hours

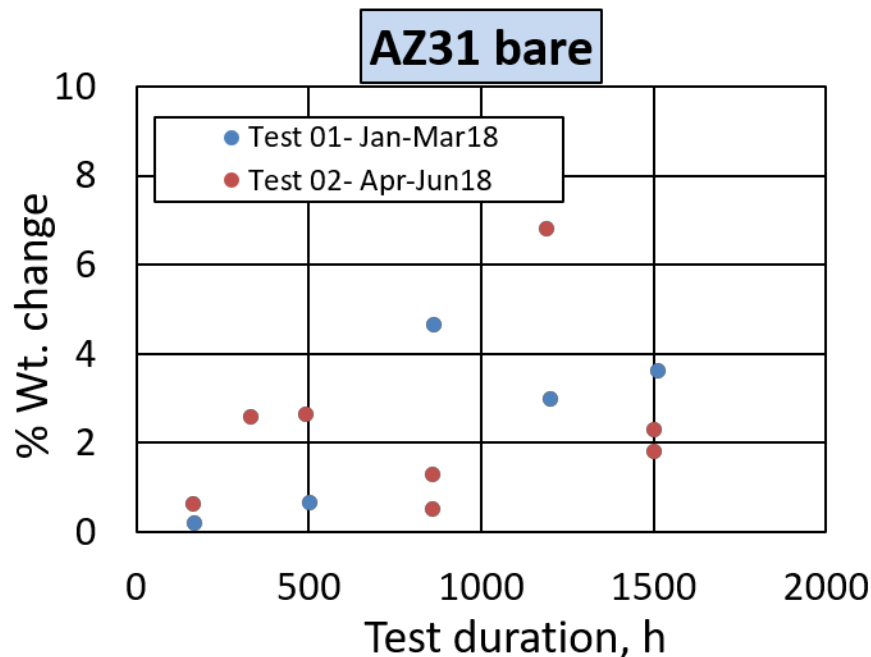
*Corrosion coupons are taken out from the test chamber at a regular interval, dried, and weighed. % weight (wt.) change indicates the degree of corrosion*

Significant weight gain → heavy corrosion

- Bare AZ31 shows severe corrosion during salt fog test → Significant weight gain due to  $\text{Mg}(\text{OH})_2$  formation
- Under corrosion conditions used (ASTM B117 test), both HP and HPEC offer good corrosion protection but HPEC appears better
  - As-coated HP layer is porous and not impervious to corrosion attack and showed some evidence of cracking at HP/AZ31 interface
  - As-coated E-coat layer is dense and remains dense during testing
- The HP/EC interface has strong integrity and does not delaminate under corrosion conditions used
- Compatibility between the joining method and coating schemes is being evaluated
  - Arplas resistance spot welding required the HP layer to be removed to expose base Mg on at least on both sides of the top sheet along with the mating side of the underlying bottom sheet of the work pieces

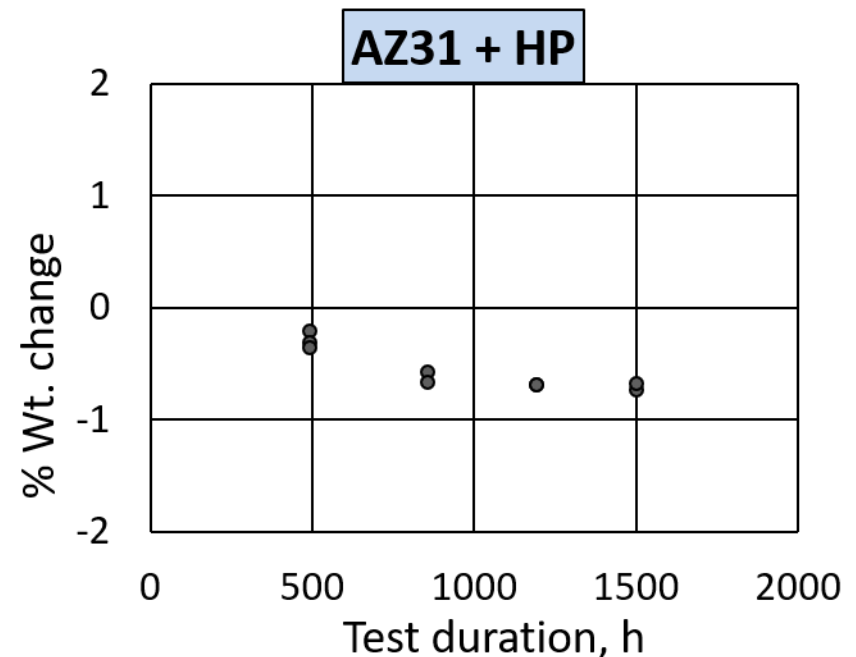
Slight loss of weight → Slow dissolution of the protective coating

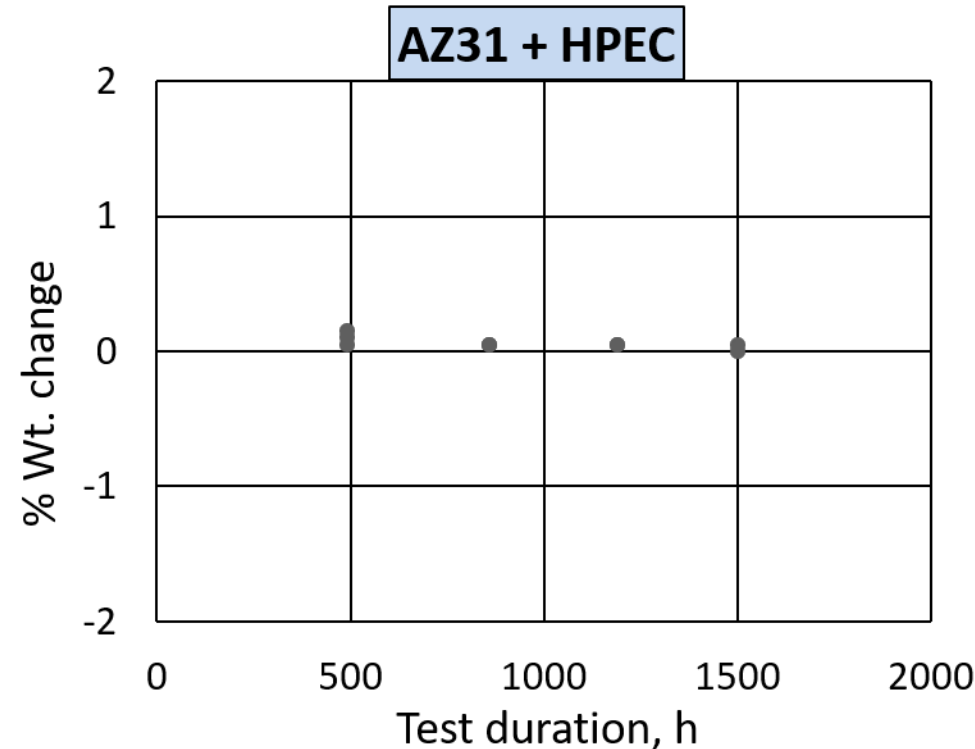
No change in weight over the test duration, indicating **best corrosion protection in AZ31 + HPEC sheets**

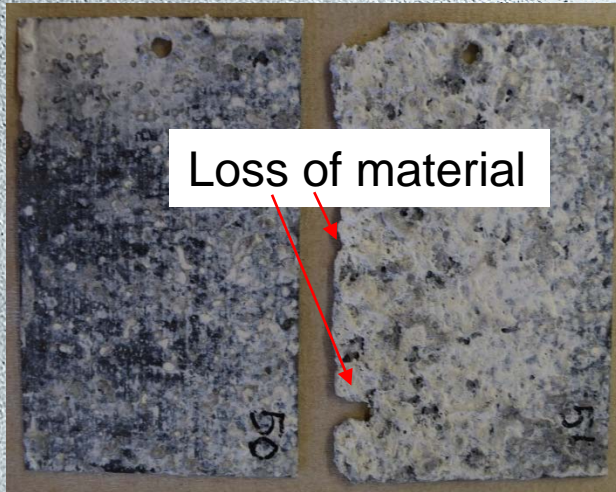
Bare AZ31

Significant corrosion

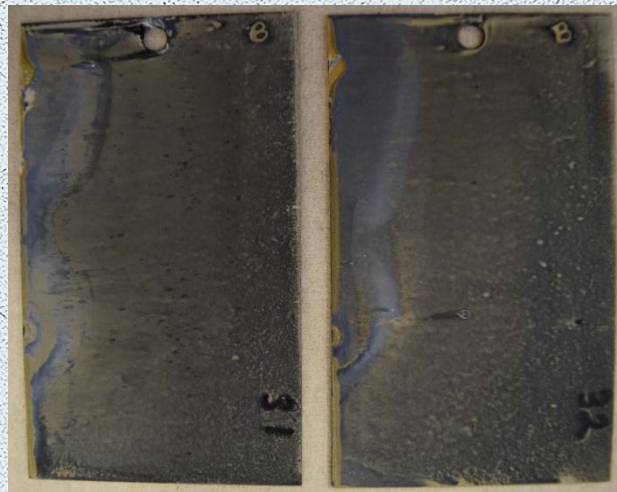
AZ31 + HP

Discoloration of the protective layer

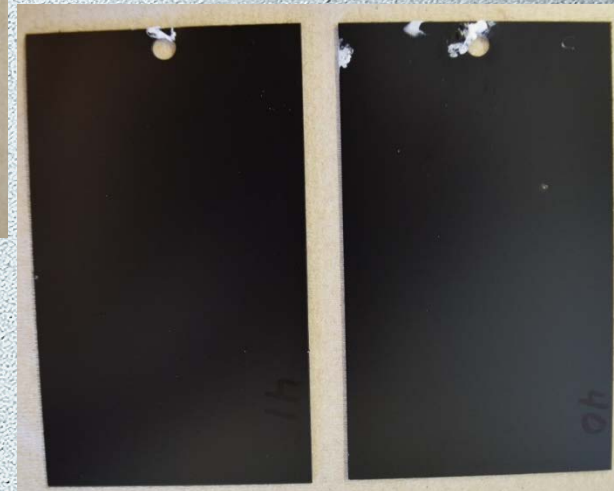
AZ31 + HPEC

No apparent change in the protective layer

***Best corrosion protection is noted in HPEC coating***

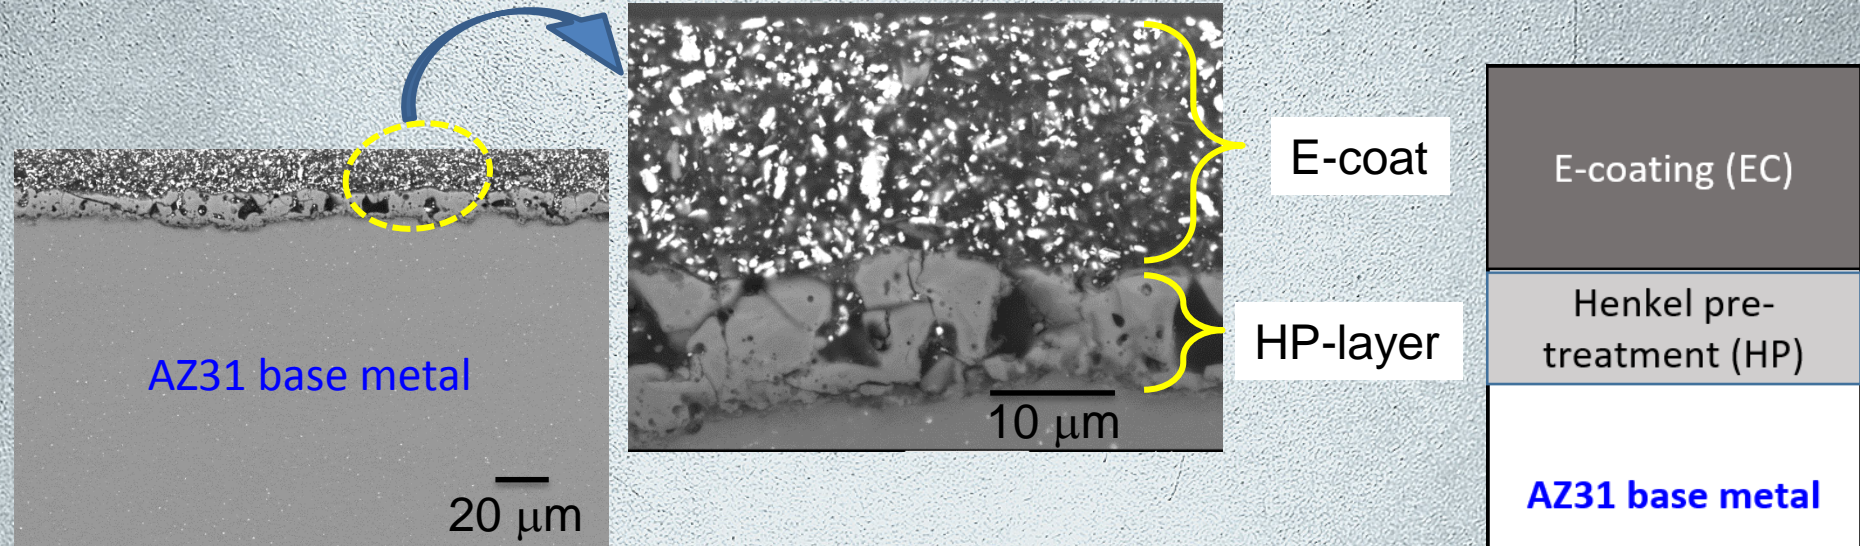
Characterization of the AZ31 + HPEC coupons (SEM + EDS analysis), **t = 850 h**

- **HP layer: Contains pre-existing pores**
- **E-Coat: No apparent change and remains dense even after 1500 h**

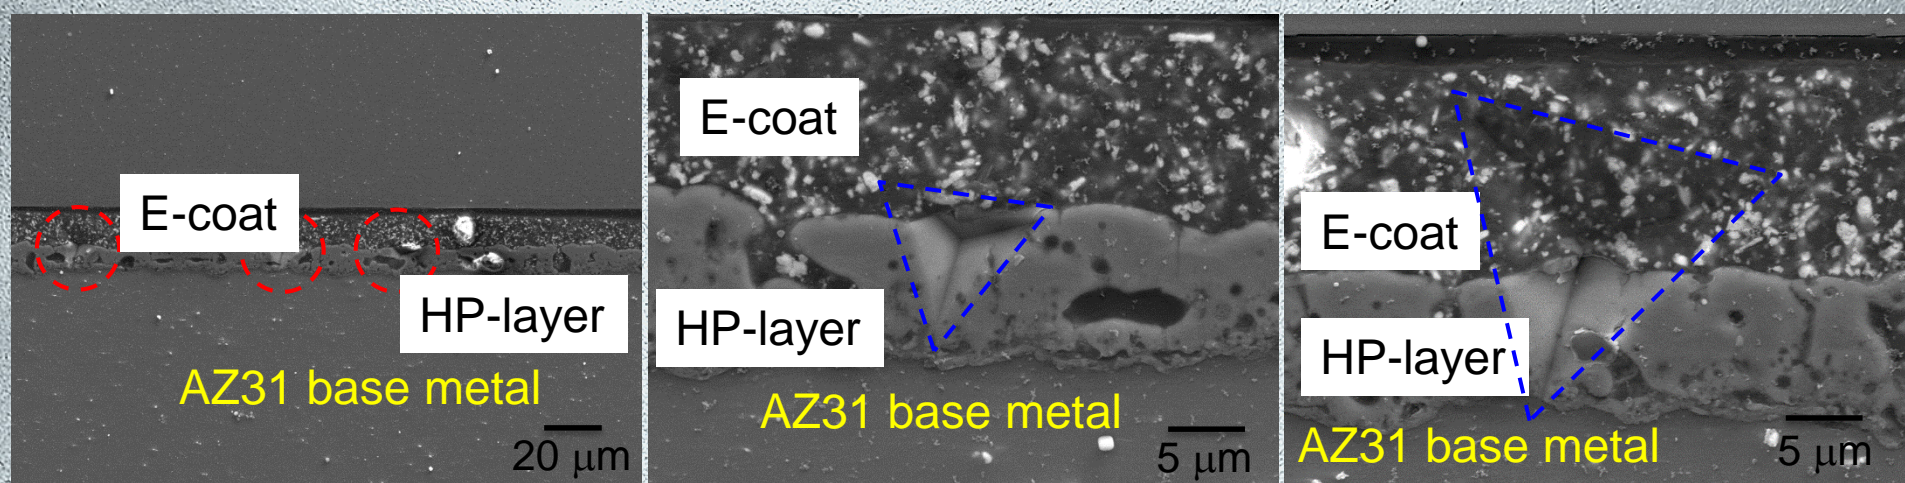
## Mechanical Integrity of HPEC

- The HP/EC interface appears to be stable, and does not delaminate under the application of point loads
- HP-layer contains numerous pores which get covered by the E-coating process
- E-coating provides a dense top layer to the underlying HP-layer
- Exposure of the base metal is thus stopped and improves corrosion performance.

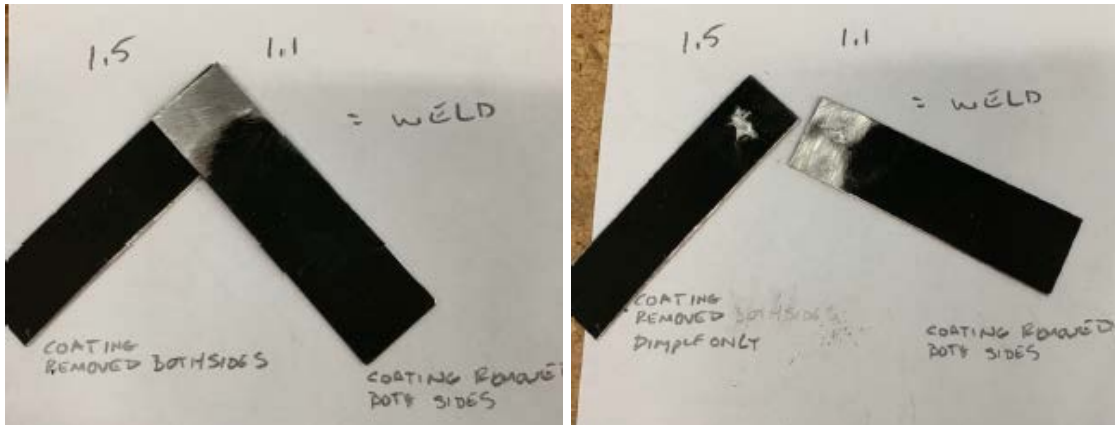
ARPLAS RESISTANCE  
SPOT WELDING

Successful Arplas welding only possible when pre-treatment layer (HP) is removed on both sides of each sheet metal coupon

1.5 mm thick AZ31 sheet being joined to 1.1 mm thick AZ31 sheet

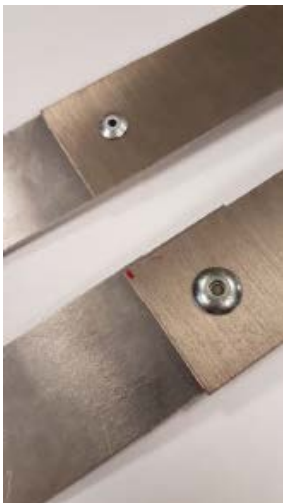
Rivet Head

- Both 3/16" and 1/4" all-Aluminum style rivets initially tested
- Closed-end 3/16" rivets chosen for further studies
- Advantage: Completely sealed rivet tail end prevents environmental/ chemical intrusion on tail end

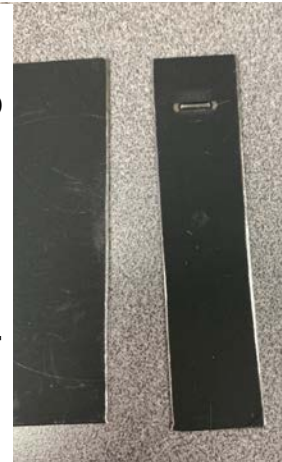
Arplas Resistance  
Spot Welding

Examples of Mg-joints supplied  
by Magna

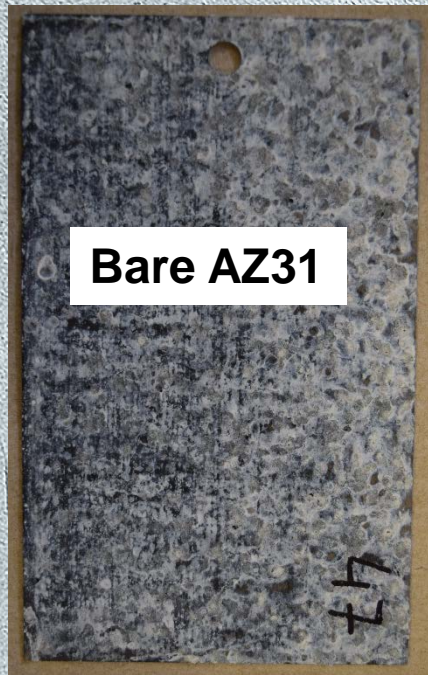
# Images of the corrosion test coupons after 500 h of exposure

Significant corrosion

Slight discoloration  
of the protective  
layer in HP samples

No apparent change in  
the protective layer

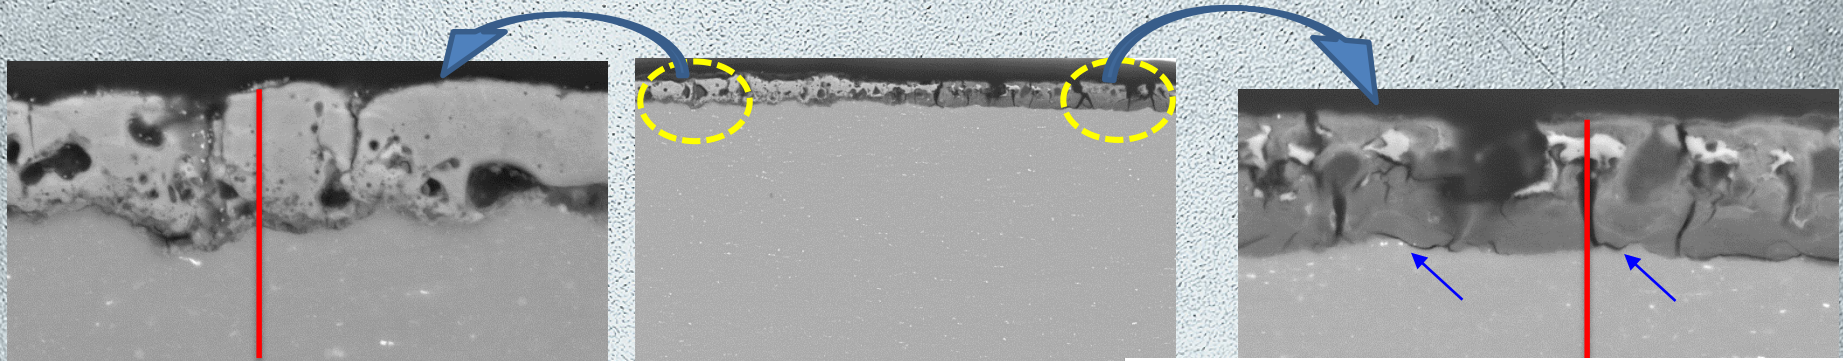
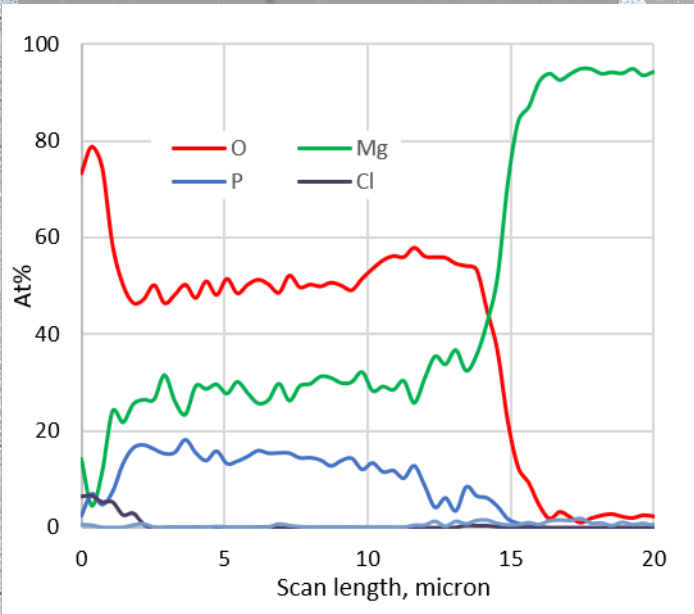
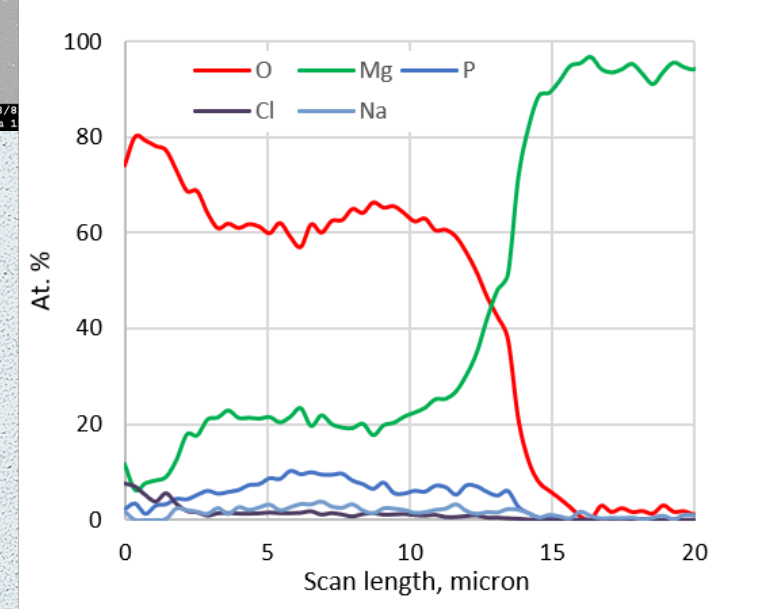
# AZ31 + HP coupons (SEM + EDS analysis) , $t = 850$ h

**Formation of Mg-hydroxide on areas where HP-layer got removed, confirmed by EDS and XRD. Cracks noted at the metal IF, shown by arrows**

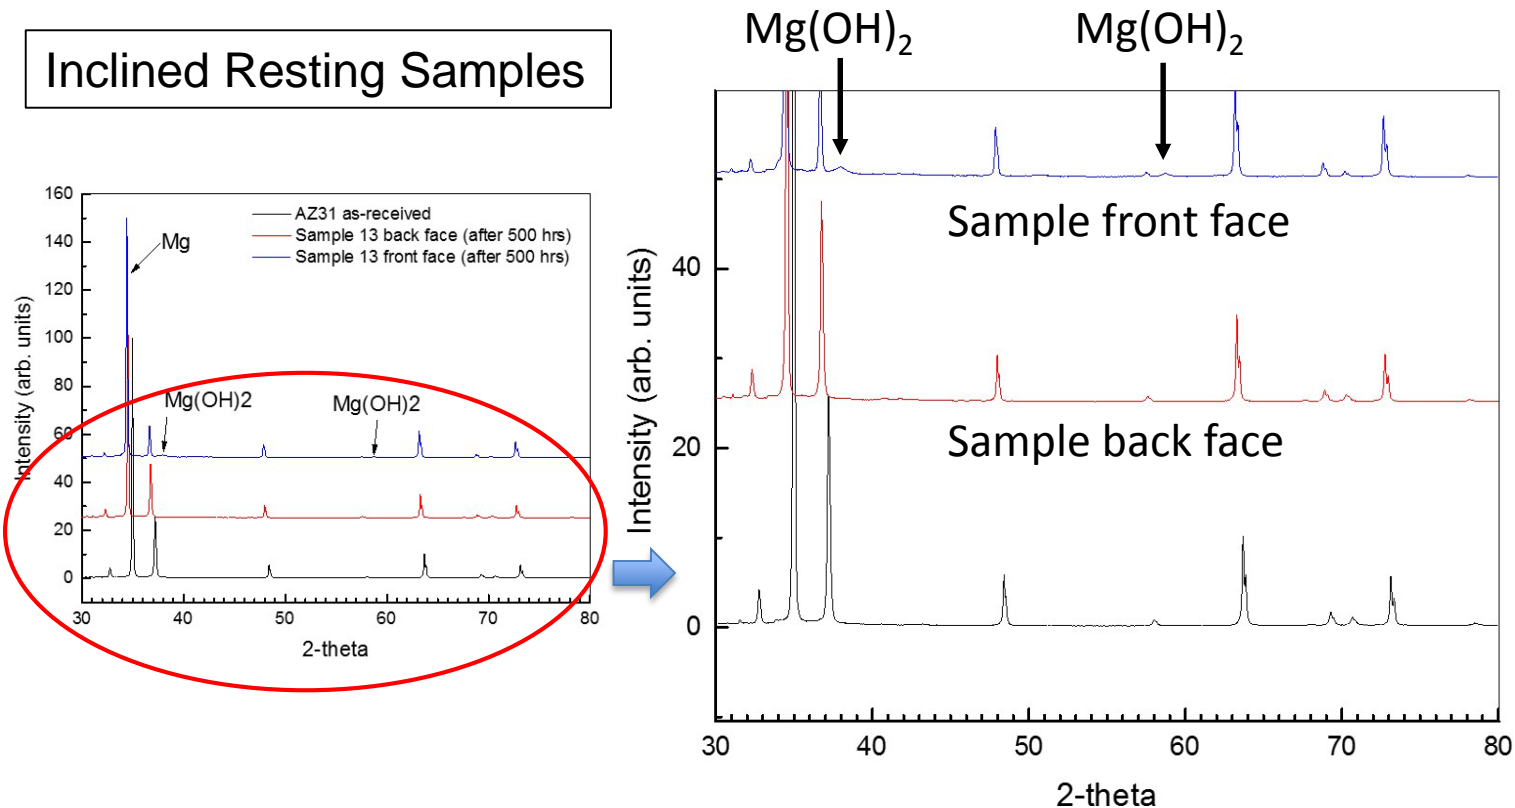
# X-ray Diffraction of Corrosion Products

- XRD analysis confirmed the presence of  $\text{Mg(OH)}_2$  as the corrosion product, on the front face

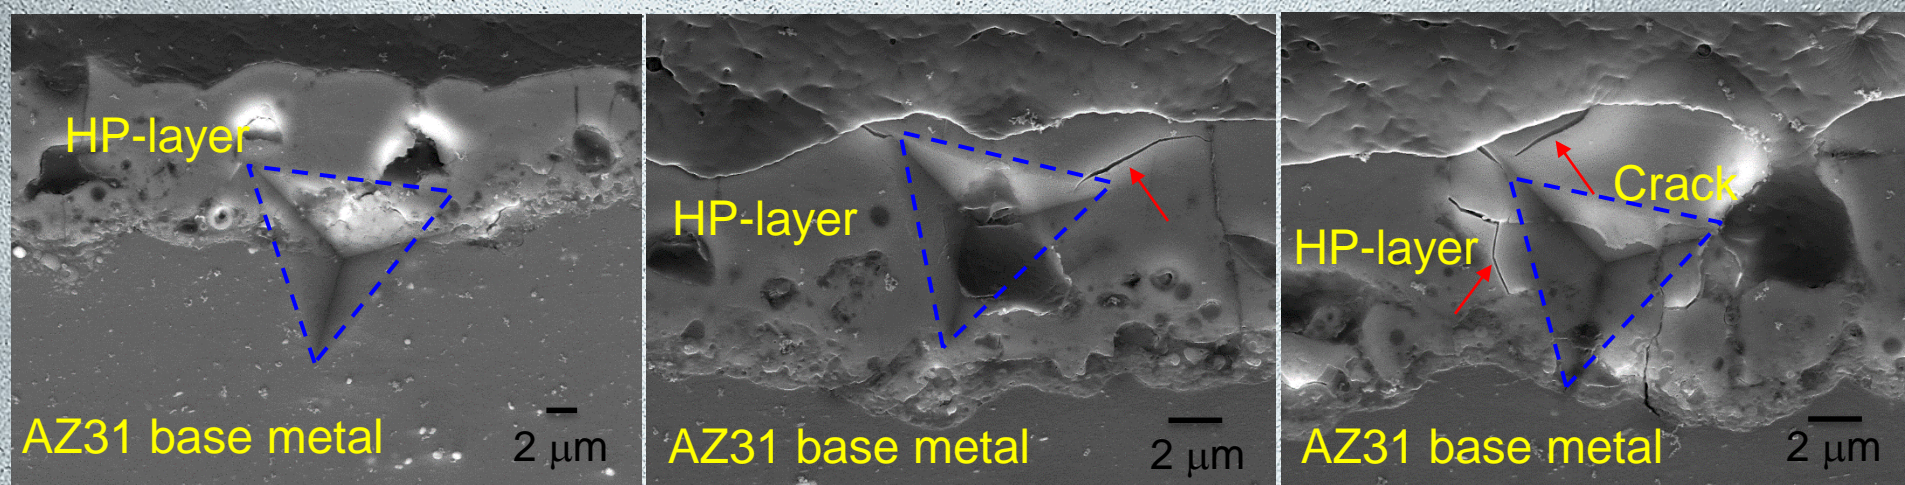
# Indentation along coating/base metal to check coating integrity, AZ31 + HP Coupons

- Nano-indentation along the HP-layer/metal interface and inside the HP-layer carried out (0.1-1 N, Berkovich indenter)
- Signs of interfacial failure/coating delamination at HP-layer/Mg-base metal interface is not evident.
- A few cracks can be noted within the coating, but not extensive
